## CASE STUDY

### Repair of Fibre Composite Cylindrical Array Dome for the Collins Class Submarine

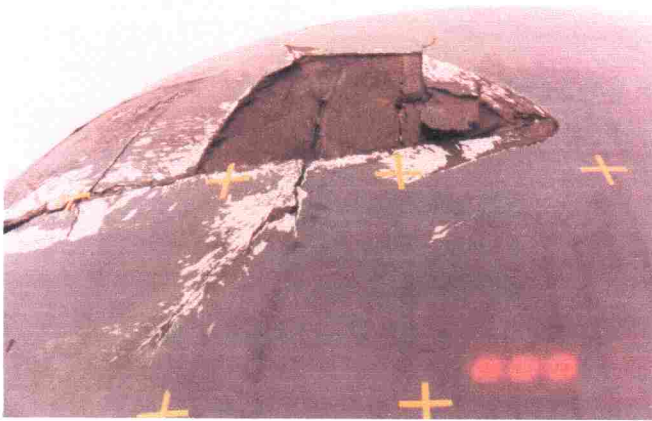
**The Problem.** The Carbon and Glass Fibre Cylindrical Array Dome suffered a 1.5 metre by 2 metre penetration damage and the RAN was advised that it was unrepairable. BAC was approached by the Submarine Project Office and a survey was undertaken.

**The Solution.** Following the approach from the Department, BAC prepared a comprehensive repair procedure and project proposal to recover the Dome, while minimising the technical and commercial risk to both the company and the RAN. This proposal included material testing of the recommended repair laminates and the repair technique before approval for the

major repair was undertaken. These tests were successfully completed with the laminates indicating we achieved properties approximately 50% stronger than the specification for the pristine laminates and 47% stronger for the repaired laminate.
